## RELIABILITY AND FAILURE RESISTANCE OF THE STONE BRIDGE STRUCTURE OF CHARLES BRIDGE DURING FLOODS

Jiri Witzany<sup>1</sup>, Tomas Cejka<sup>2</sup>

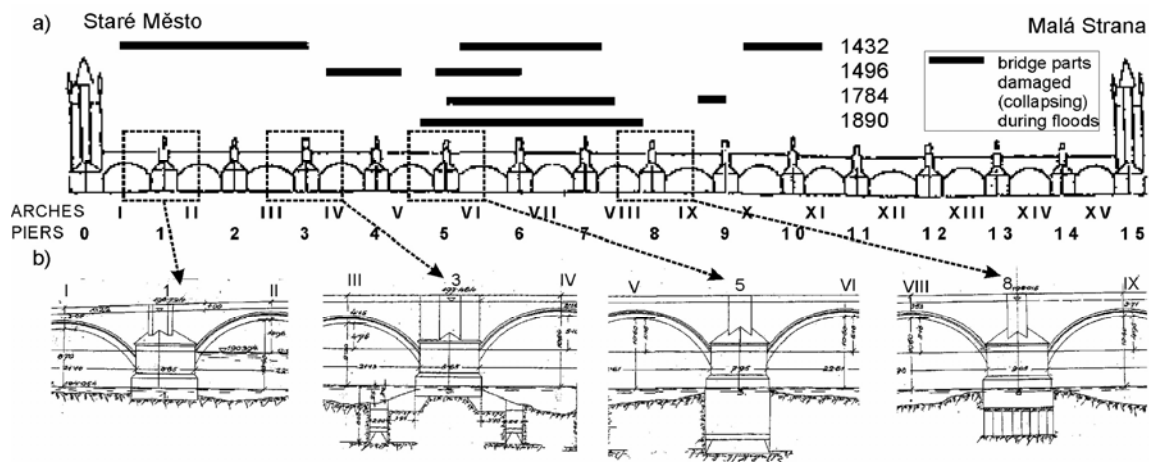
**Fig 1.** a) Historical development of Charles Bridge structure (according to V. Mencl, 1994). b) Foundation of bridge piers 1, 3, 5 and 8 (documentation of 1905). Legend: – in 1902-04 shallow foundations of piers 3, 4 and 7 were secured with caisson collar beams consisting of 7 separate blocks reaching a level of Silurian slates, rehabilitation pier 8 using a collar beam of stone blocks with a sealing concrete slab of variable thickness; in 1892 foundations of bridge piers 5 and 6 were restored on caissons, in pier 8 the restored pier part, damaged in the flood of 1784, was founded on piles in 1902-04

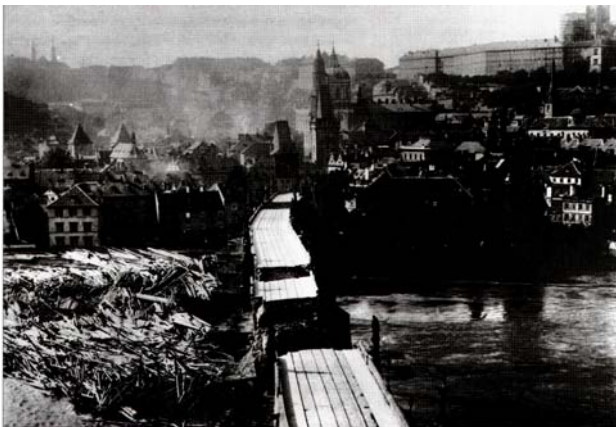
**Fig 2.** Collapse of 3 bridge vaults and piers of Charles Bridge during the flood of 1890

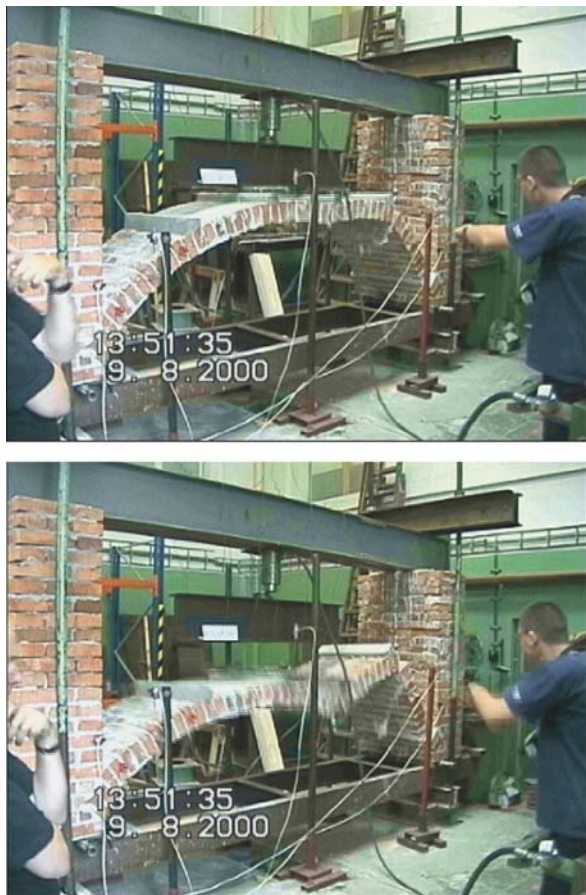
**Fig 3.** Vault failure under load (buckling of right vault section)

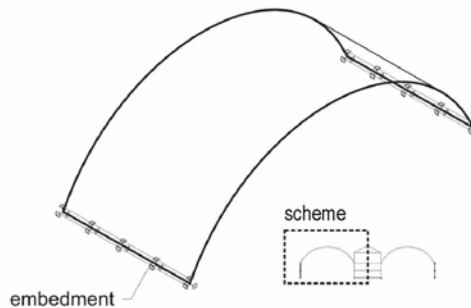
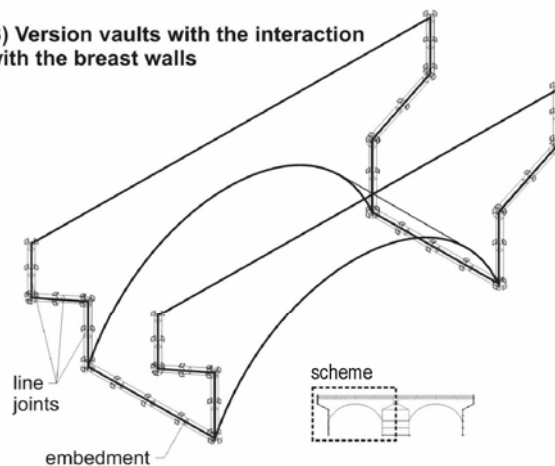
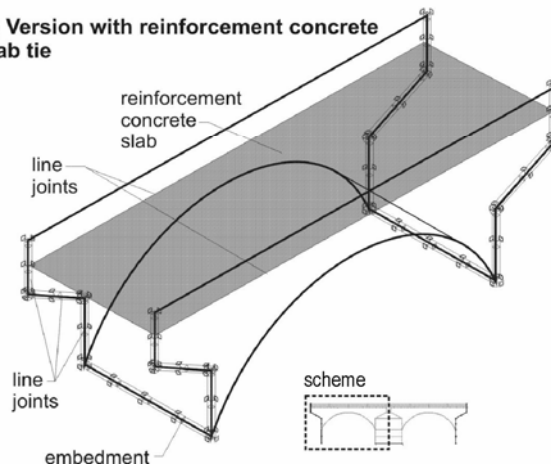
**• A) Version vaults**

**• B) Version vaults with the interaction with the breast walls**

**• C) Version with reinforcement concrete slab tie**

**Fig 4.** Scheme of investigated models of stone bridge structure

The numerical analyses were made for several computational models of the bridge structure, and their results are presented in the text below for the case (Fig 4) of vaults on their own without the interaction with the breast walls, with the interaction with them and with the breast walls coupled by line joints to a reinforcement concrete slab tie of 200 mm thick (modification executed in some bridge spans during the repair in 1967–75).

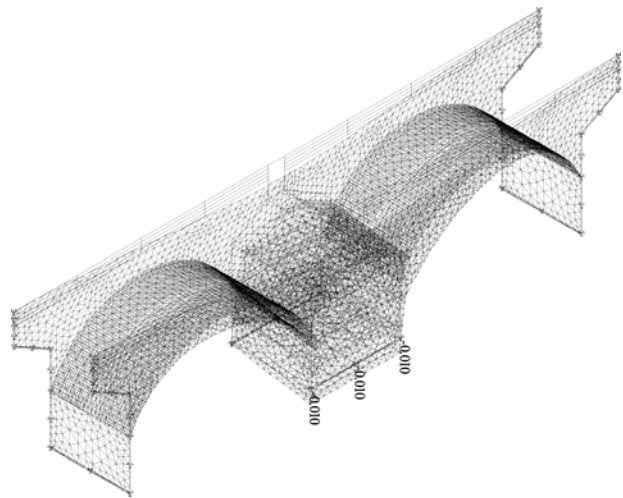
Fig 5. Diagram of bridge span deformations with angular rotation in pier footing bottom

A theoretical computation using the finite-element method proved that the rotation of the bridge pier footing bottom at an angle  $\varphi = 0,06^\circ$  (subsidence of the bridge pier downstream edge by 10 mm, Fig 5) is accompanied by the appearance of transverse tensile stresses  $+\sigma_y$ , with

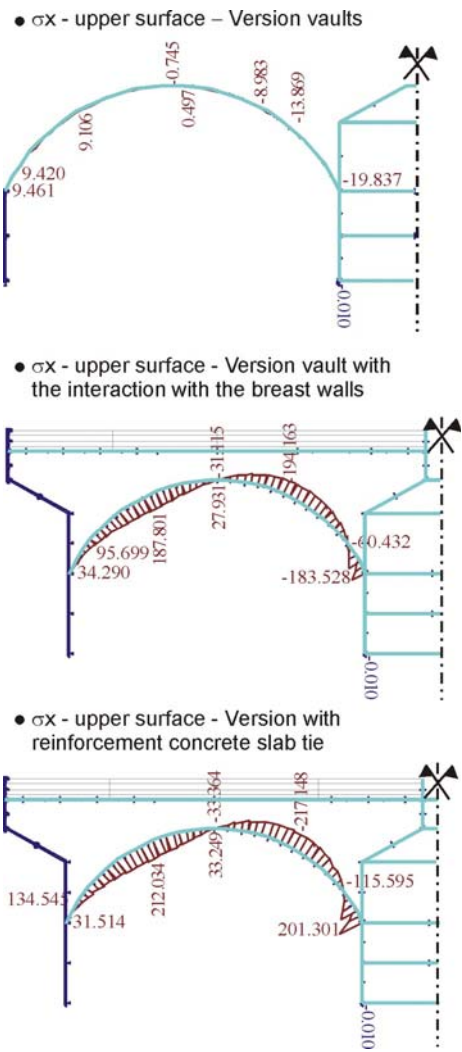
Fig 7. Comparison of normal stress  $\sigma_x$  values in a characteristic cross-section of stone bridge structure

extreme values in the bridge vault section adjoining the subsided edge of the bridge pier (Fig 6) and by the appearance of longitudinal tensile normal stresses  $+\sigma_x$  (Fig 7) with extreme values in boundary areas of the bridge vault adjoining the subsided edge of the intermediate bridge pier. In this part of the bridge vault, the tensile stress  $+\sigma_x$  acts across the whole cross-section, its numerical values considering the actual rotation (subsidence) values significantly exceed not only potential adhesion in the "mortar-stone" contact joint, but also the tensile strength of sandstone blocks. Fig 7 schematically depicts the bridge vault section, where the tensile normal stress  $+\sigma_x$  acts across the whole cross-section, and where complete disintegration and failure of the bridge vault stone masonry may be presumed.

The normal stresses  $\sigma_x$  and  $\sigma_y$  in the stone masonry of the bridge vault with the breast walls coupled to the 0,2 m thick concrete slab by means of a pinned joint, there is a growth in the stress state of the actual vault stone masonry of 20 to 40 %. The lowest values of the normal stress  $\sigma_x$  and  $\sigma_y$  in the vault stone masonry arise in version "A", ie with eliminated interaction of the bridge vault and the breast walls (Figs 7–9).

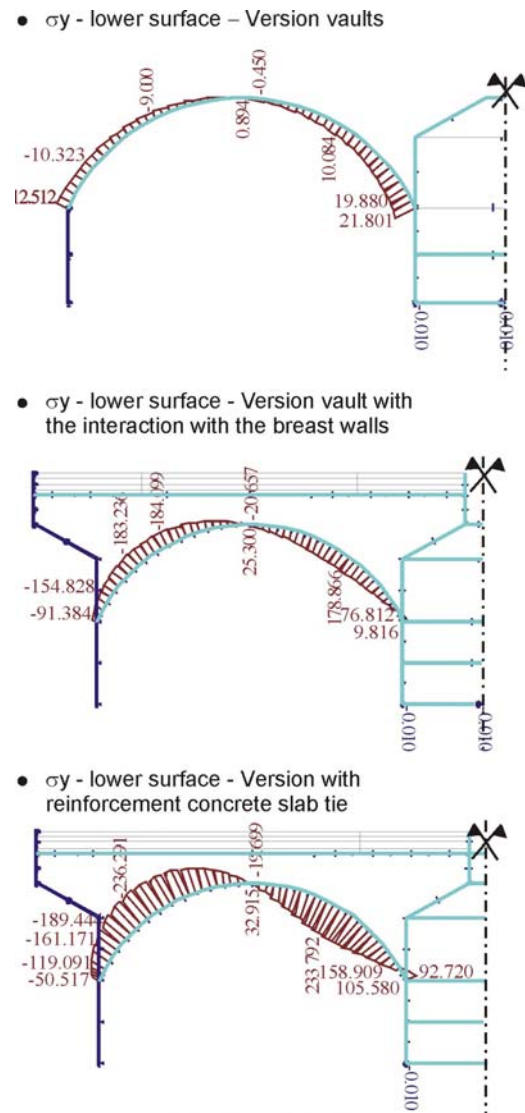
Fig 8. Comparison of normal stress  $\sigma_y$  values in a characteristic cross section of stone bridge structure

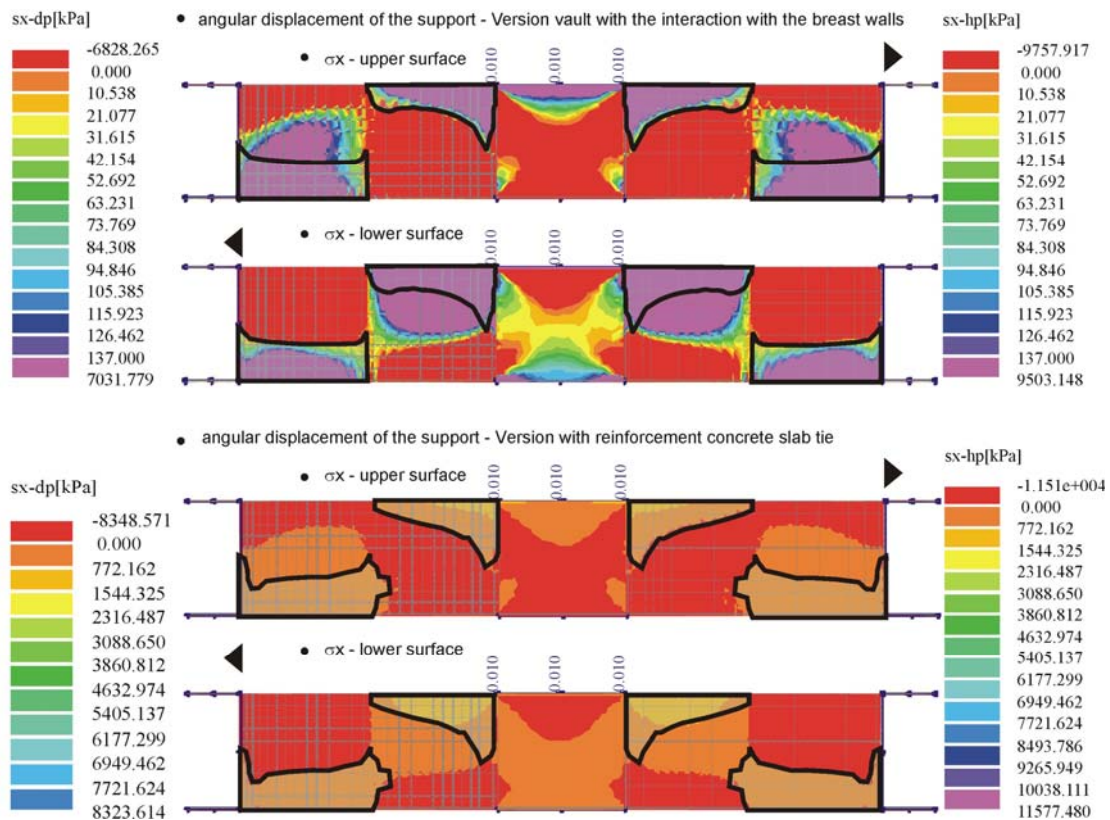
**Fig 9.** Areas of tensile normal stress  $+\sigma_x$  occurrence acting along whole vault cross-section (areas of tensile stresses acting along whole cross-section highlighted in bold) first iteration – response of structure

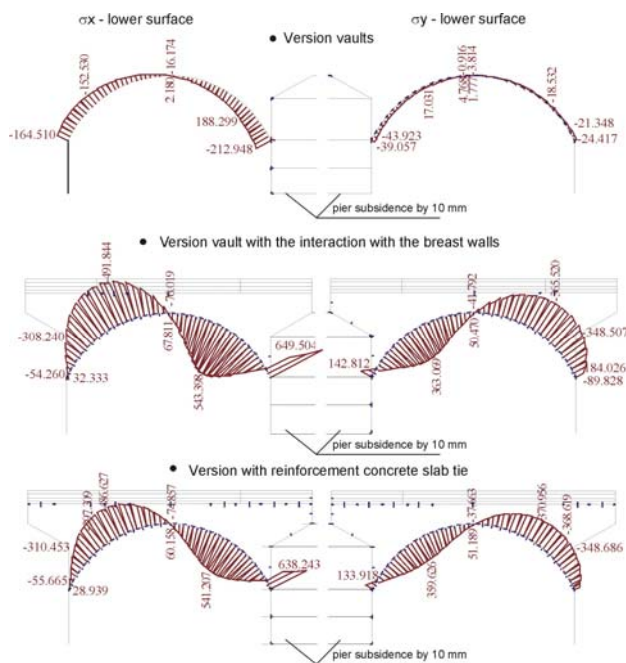
Fig 11. Scheme of course of normal stresses  $\sigma_x$  and  $\sigma_y$  in longitudinal vault axis at pier subsidence by 10 mm

- In case of the bridge pier subsidence (Figs 10, 11), due to the effect of the vault interaction with the breast walls, there is an increase and a considerable change in the transverse normal stresses  $\sigma_y$ . When the breast walls are coupled by means of a reinforcement concrete slab tie, there is an additional growth in transverse normal stresses in the vault masonry by 30 to 60 %, as compared to versions with the breast walls; longitudinal normal stresses  $\sigma_x$  in the bridge vault version, ie vaults on their own, as compared to the version of bridge vaults interacting with the breast walls and the version where the bridge vaults interact with the breast walls coupled by means of a reinforcement concrete slab tie, ie including the interaction with the breast walls, reach values up to several times higher. The breast walls coupling by means of the reinforcement concrete slab tie negatively affects the response of the stone bridge structure to loading effects. Due to the interaction of the breast walls with the reinforcement concrete slab tie, there is a total increase in the rigidity of the bridge structure and a related additional increase in longitudinal normal stresses  $\sigma_x$  (by 30–40 %), as compared to versions of bridge vaults interacting with the breast walls.

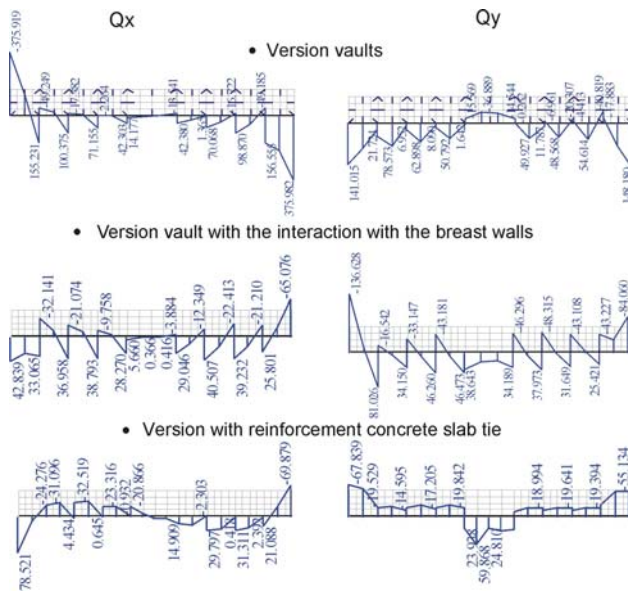
Fig 14. Course of shifting forces  $Q_x$ ,  $Q_y$  at vault toe adjoining bridge pier in which shift in footing bottom occurred

values of longitudinal normal stresses  $\sigma_x$  arise in the bridge vault reaching, as compared to the values of transverse normal stresses  $\sigma_y$ , values more than twice. The differences in the magnitude of normal stresses  $\sigma_y$  in individual cases with the breast walls are within a range of ca  $\pm 10\%$ . Considerable shifting forces arise in the footing small effect of the reinforcement concrete slab tie in terms of the “resistance” of the bridge structure to the bridge pier shift in the footing bottom is evident. The decisive finding is the interaction of the bridge vault with the breast walls – a critical point being the bed joint between the vault and the breast wall. Increased horizontal rigidity of the breast walls in case of their coupling by the reinforcement concrete slab tie will “accelerate” the bed joint failure and the successive process of the vault failure (Fig 14).
